NATIONAL TRANSPORTATION SAFETY BOARD

MATERIALS LABORATORY FACTUAL REPORT

Report No. 08-022

Place : King Salmon, Alaska
Date : September 30, 2007
Vehicle : Helio H-295
NTSB No. : ANC07FA109
Investigator : Clint Crookshanks, AS-40

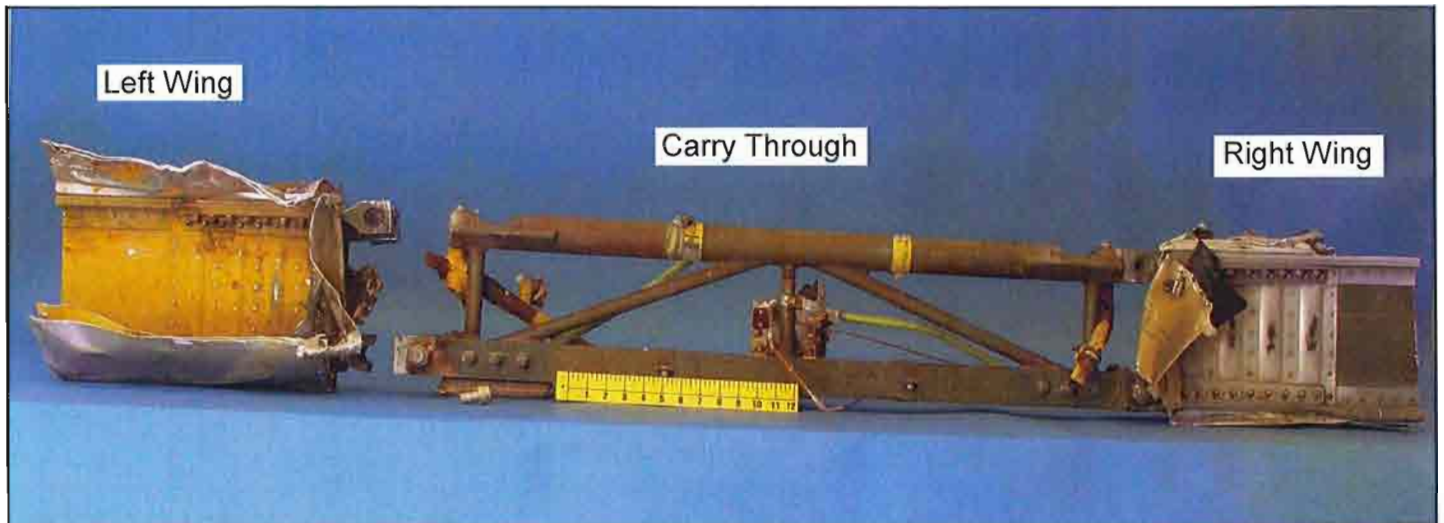
An overall view of the as received carry-through structure and adjacent portions of the left and right wing forward spars are shown in figure 1. The structure was separated at the left wing forward spar attachment to the carry-through structure as indicated in figure 1. The corresponding area of the right wing forward spar remained attached to the carry-through structure.

Figure 1--The as-received structure with separated left wing and attached right wing.

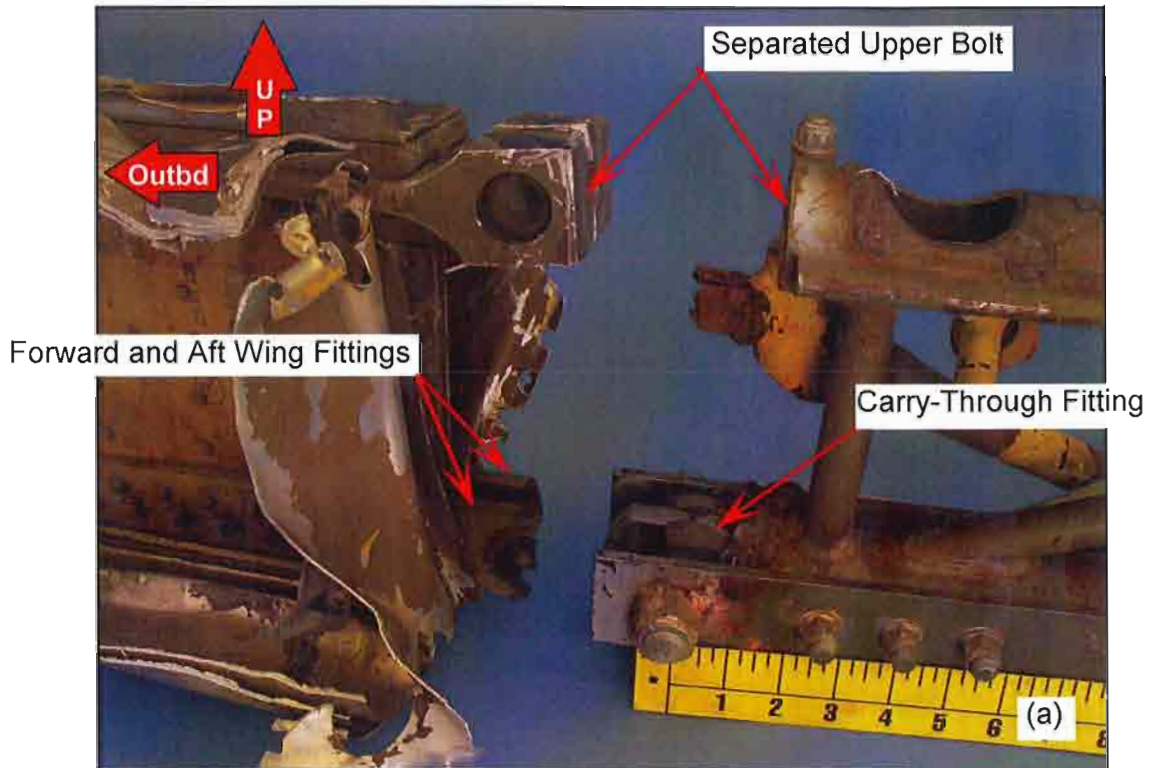
At the lower spar caps, the wings are attached to the carry-through structure by wing fittings mounted on the forward and aft sides of the spars that form clevises. The carry-through has single lug fittings inserted into each wing clevis and connected with longitudinal shear pins. Initial examinations found both fittings of the left wing fractured through the holes for the pins. The inboard portions of the clevis remained trapped within the carry-through structure. The upper caps of the wing spars are joined to the carry-through by transverse bolts threaded into barrel nuts contained within the wing structure. The left wing bolt was fractured through the shank adjacent to the barrel nut. The threaded outboard end of the bolt remaining in the barrel nut, and the shank and head portion of the bolt was received separate. Figure 2 shows an overall view of the inboard end of the left wing forward spar with the lower clevis fractures and upper bolt separation indicated.

Figure 2--The separated left wing forward spar attachment area to the carry-through structure.

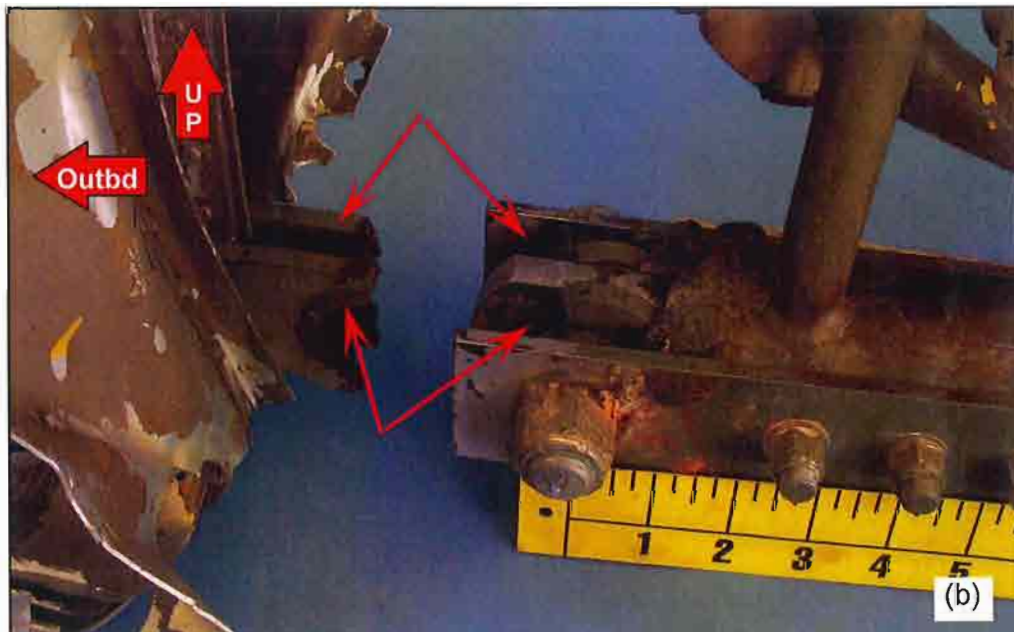
Figure 3--The fractured lower wing fittings with arrows indicating mating fractures.

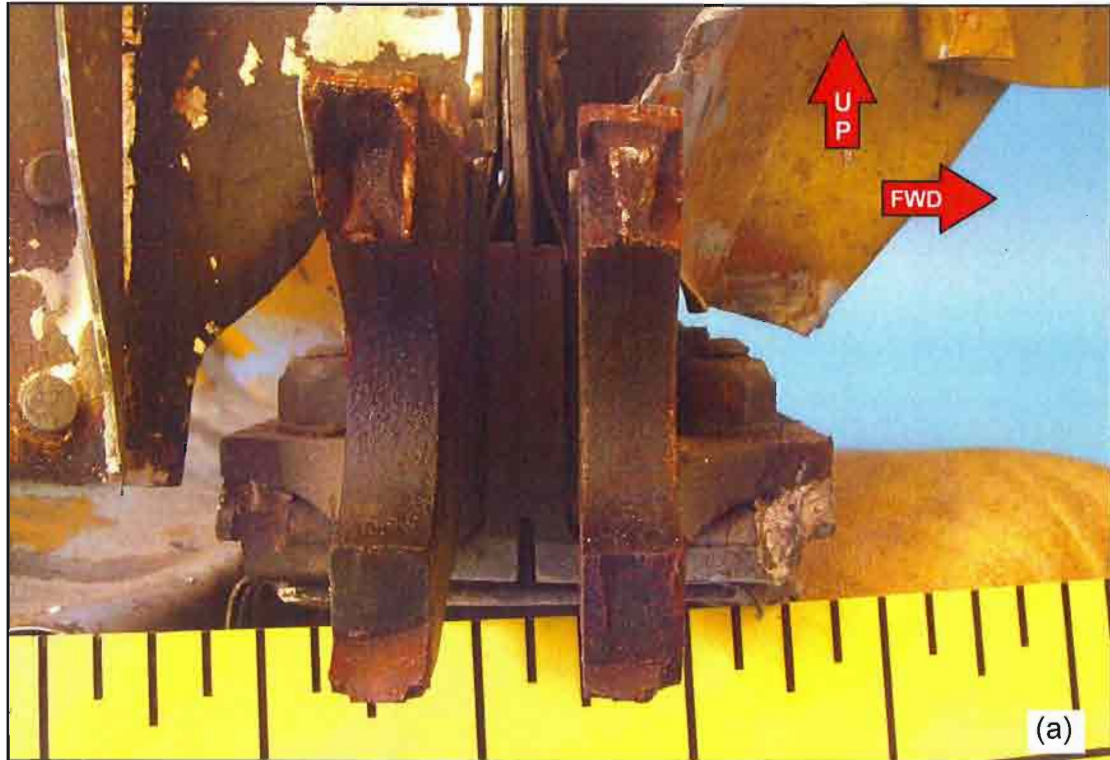
Figure 4--The outboard fractures faces of the lower wing fittings. Looking outboard.

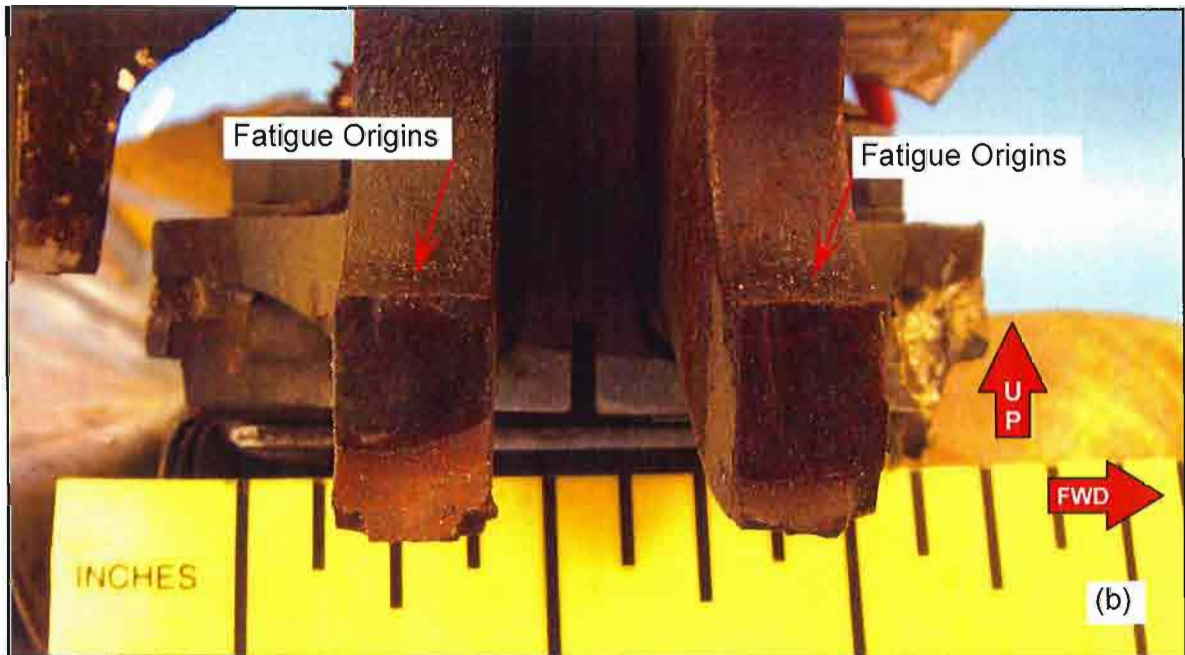
Although heavily corroded and darkened, magnified examinations of the fractured left wing fittings revealed generally smooth, flat fracture regions with crack arrest markings typical of fatigue cracking on the fitting fractures below the bolt holes. The fractures above the bolt holes showed large shear lip formations, adjacent bulk yielding and fracture features indicative of overstress separations. The wing side faces of the fitting fractures are displayed in figure 4 with the fatigue regions denoted. Figure 5 shows a higher magnification view looking outboard at the fatigue fractures below the bolt holes. Both fatigue fracture areas contained several ratchet marks¹ adjacent to bore surface of the pin hole, indicating multiple initiation sites on the bore surface. Extensive corrosion of the fracture and adjacent surfaces prevented establishing the exact locations and number of fatigue origins. Some of the origin locations are indicated by arrows in figures 5 and 6. Fatigue features extended downward from the origin areas through approximately 70% (about 0.41 inch) of the aft fitting fracture and about 80% (about 0.49 inch) of the forward fitting fracture. Approximate fatigue termini are indicated by the dashed lines in figure 6. The fracture regions below the fatigue were on slant planes with rougher features, typical of overstress separations.

Figure 5--Closer view of the fatigue fracture areas below the bolt holes on the wing fittings with approximate fatigue origin locations denoted. Looking outboard.

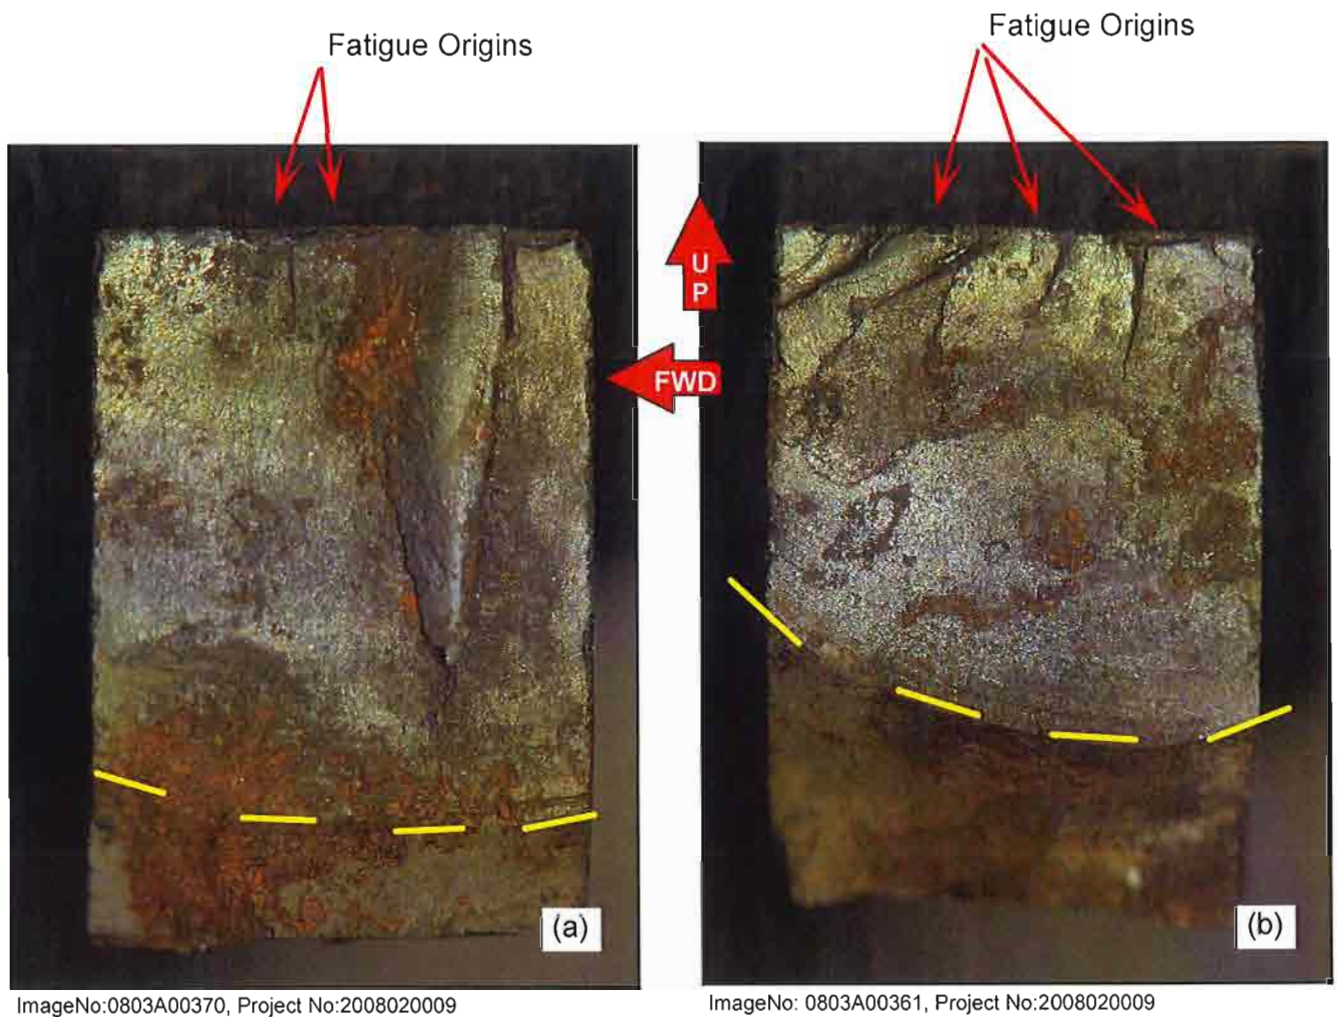
Figure 6--Closer views of the cleaned inboard faces of the forward (a) and aft (b) fatigue fractures in the left wing lower fittings. Fatigue termini are denoted by dashed yellow lines. The bore surface is at top with some of the fatigue origins denoted. Viewed looking outboard.

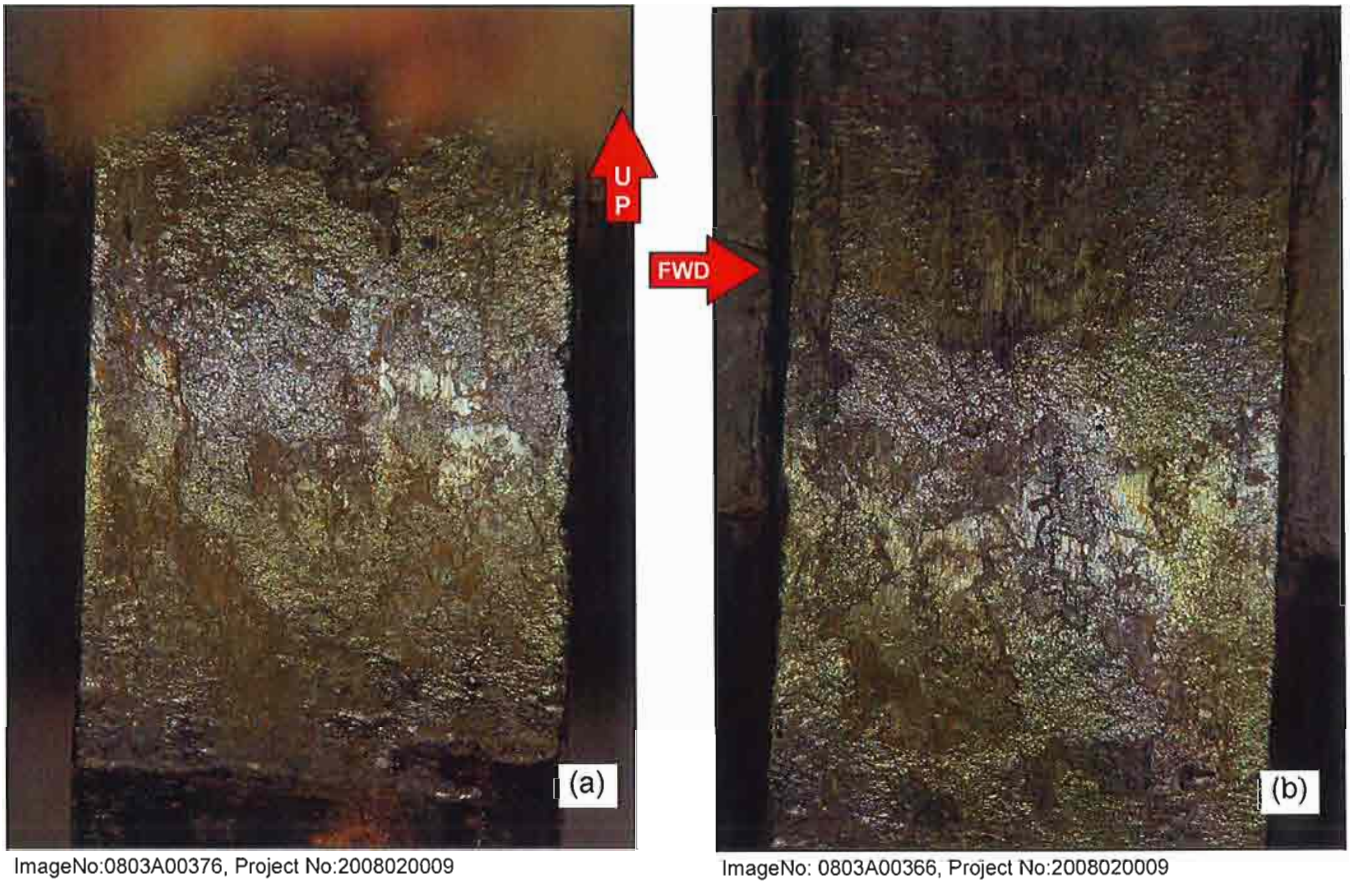
Both fitting bore surfaces showed extensive surface corrosion with little original surface remaining, as shown in figure 7. The original surface that was present was also severely corroded. The corrosion appeared as general surface wasting with only a few shallow pits formed. A transverse metallographic section through the aft fitting revealed that the bore surface contained a relatively uniform layer of corrosion products and widely spaced shallow (0.001 inch) corrosion filled pits as displayed in figure 8 (a). In addition, an oxide filled crack was uncovered adjacent to the fracture surface as shown in figure 8 (b) and (c). The crack measured approximately 0.016 inch deep.

Figure 7--The bore surfaces of the forward (a) and aft fittings showing extensive surface corrosion with little original surface remaining.

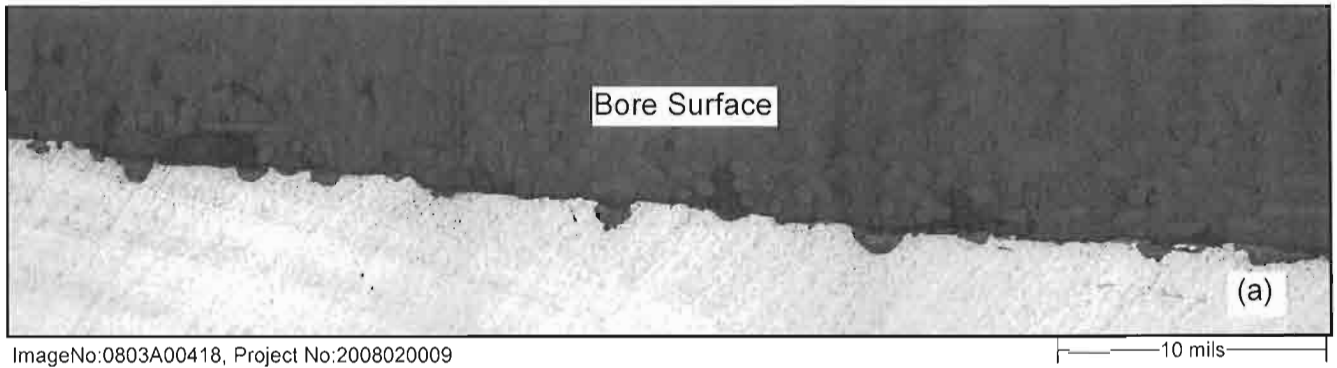
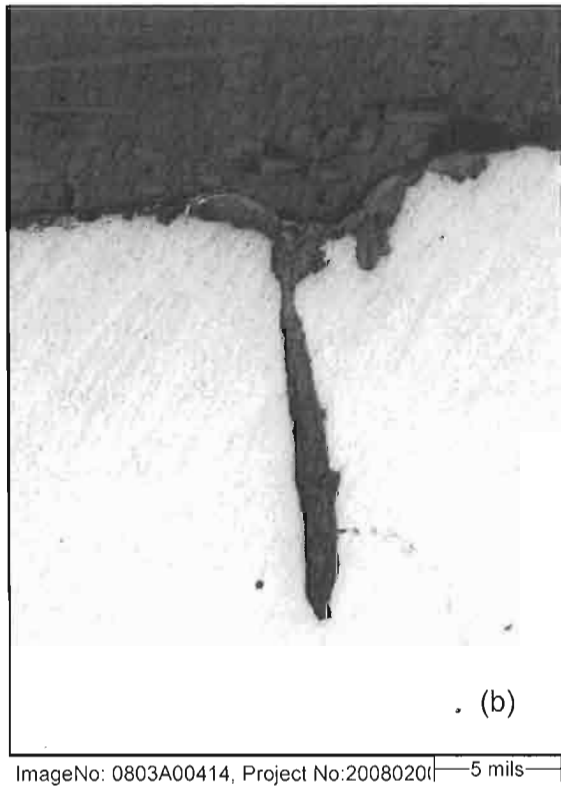
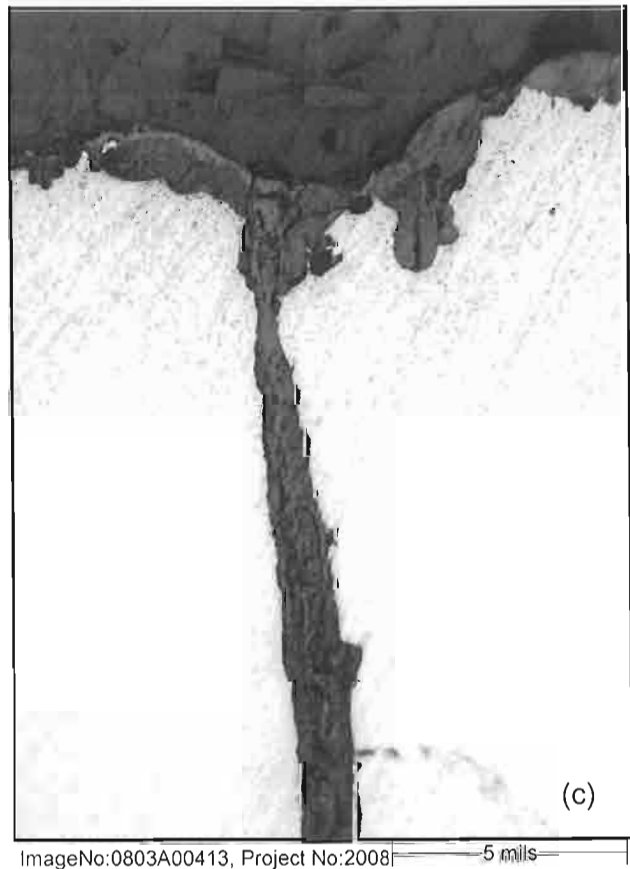
Figure 8--Metallographic section through the bore of the aft fitting showing the general surface corrosion with occasional shallow pits (a). Views (b) and (c) display an additional oxidized crack adjacent and parallel to the fracture.

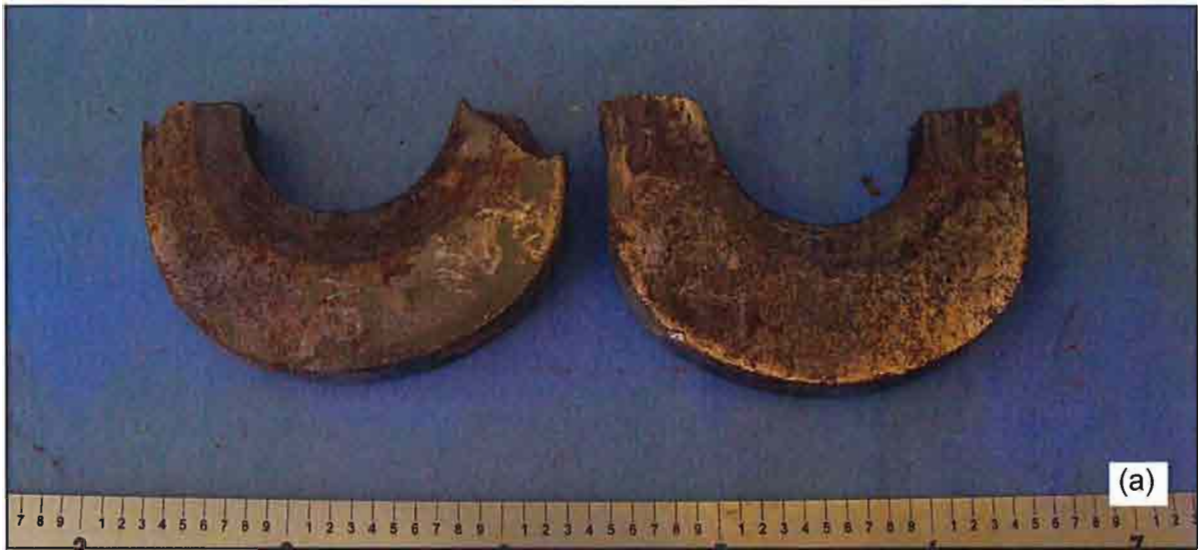
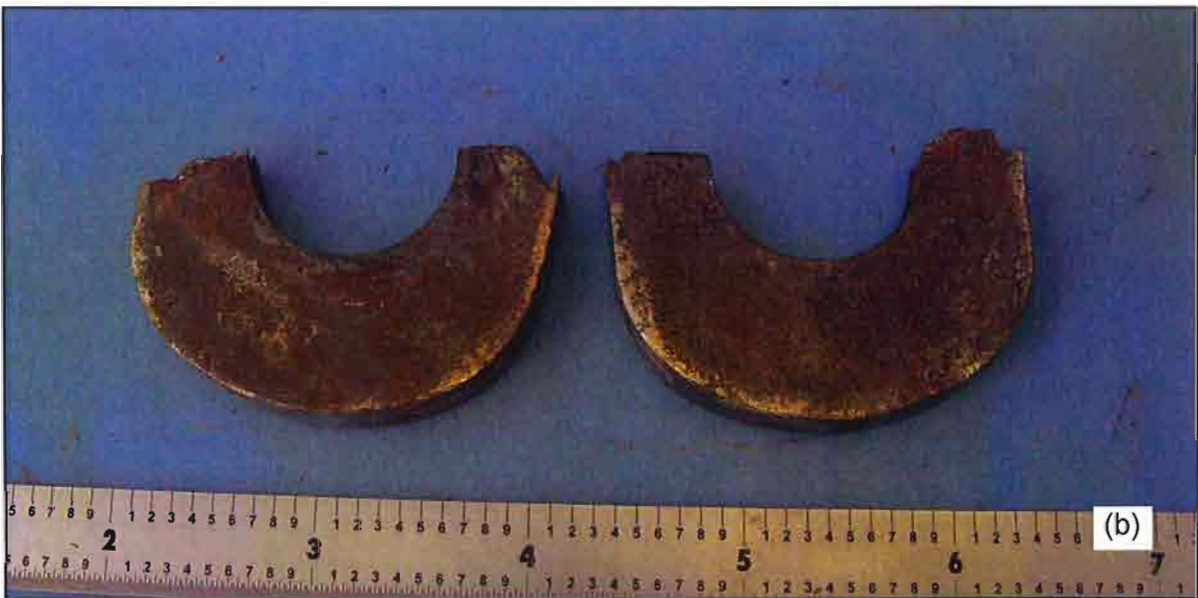
The faces of the fitting pieces also displayed corrosion to various extents. On the exposed faces (forward face of forward fitting and aft face of the aft fitting) of the fittings, shown in figure 9 (a), the corrosion had removed local areas of the cadmium plating and discolored the surfaces of the fittings but only a few surface penetrating pits were found. The hidden faces of the fittings (against the carry-through fitting) were more heavily

damaged with almost all of the plating removed and extensive pitting of the surface, as shown in figure 9 (b). In areas not previously cleaned, the top coat and primer were easily removed with acetone and light brushing. As shown in figure 10, much of the corrosion on the exposed faces had been covered by the primer and top coat paints.

Figure 9--The faces of the fractured left wing fittings showing various amounts of corrosion. View (a) shows exposed faces of fittings. View (b) the hidden faces adjacent to carry through structure fitting.

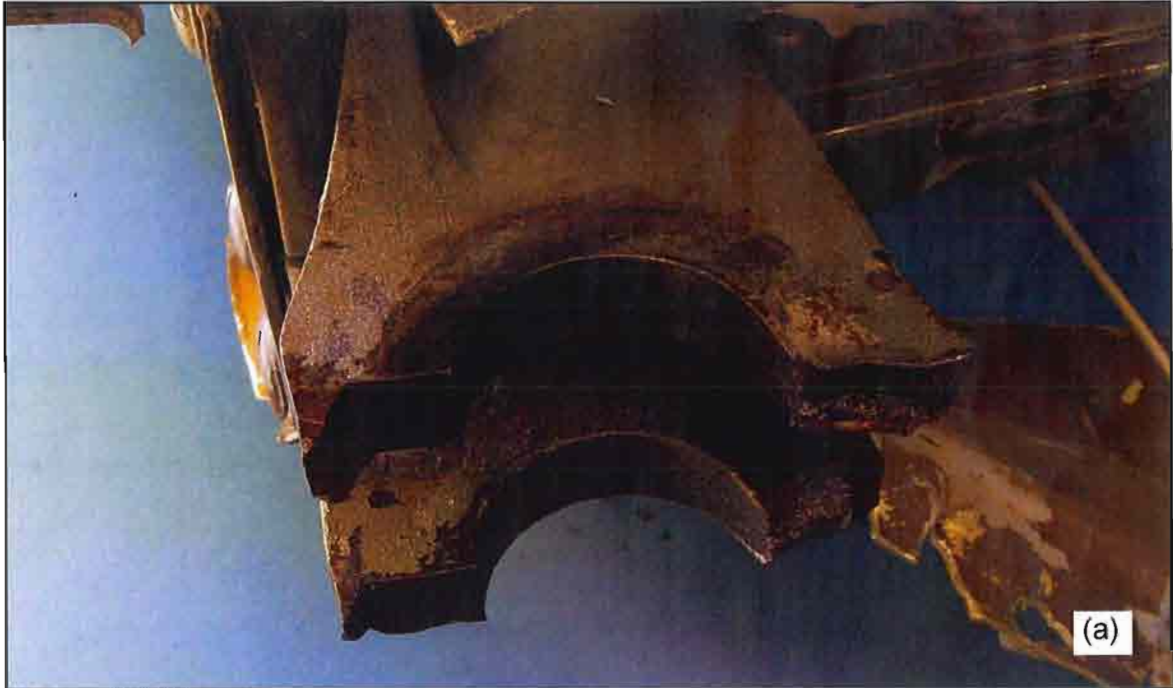
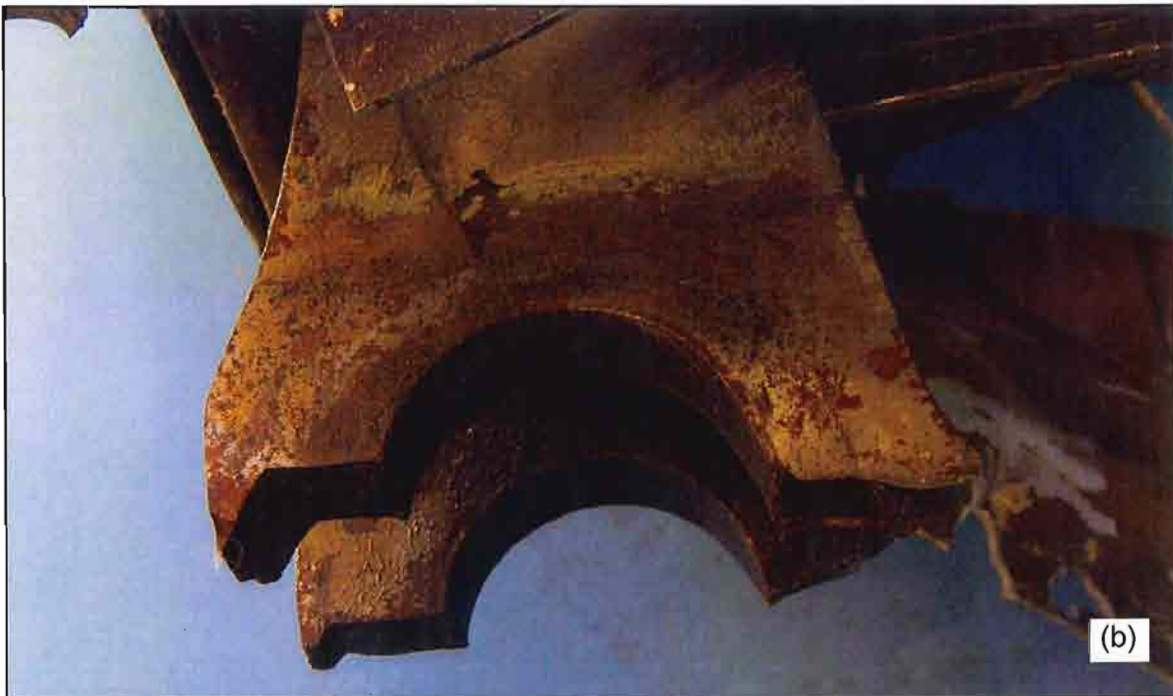
Figure 10--The aft face of the aft fitting with as received paint (a) and after paint removal (b) revealing underlying surface corrosion (dark spots).

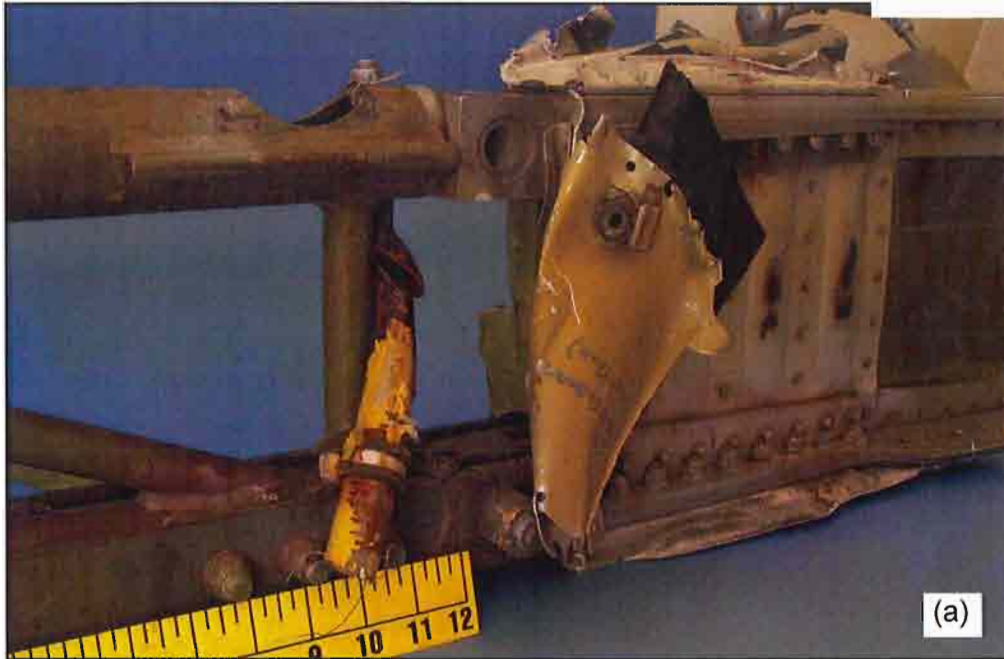
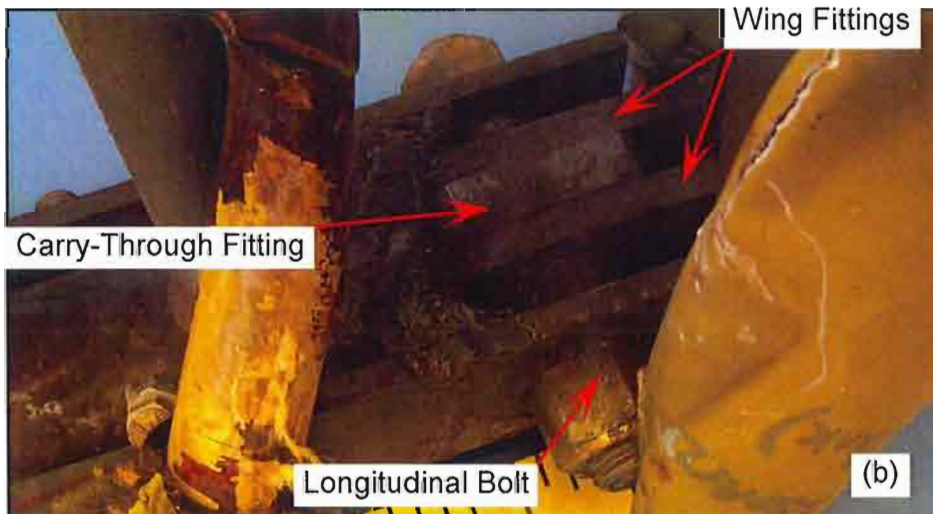
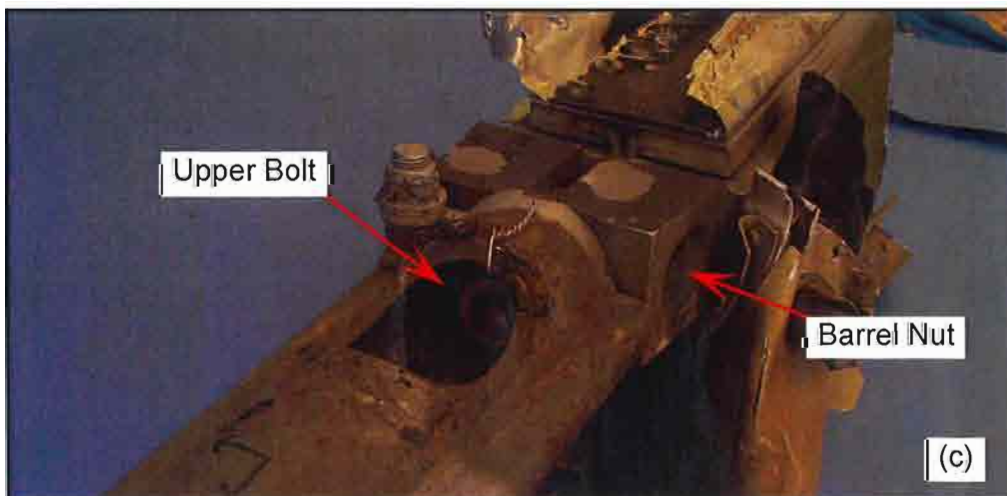
The assembled right wing attachment area is displayed in figure 11. The lower spar cap fitting and the upper bolt were intact. The adjacent wing spar area had a pronounced wing tip aft bend, and the upper wing fitting was compression damaged on the aft side, consistent with the spar deformation.

Figure 11--The intact right wing attachment (a) with a closer view of the lower attachment fittings (b) and the upper attachment bolt (c). Viewed generally from the aft side looking outboard.

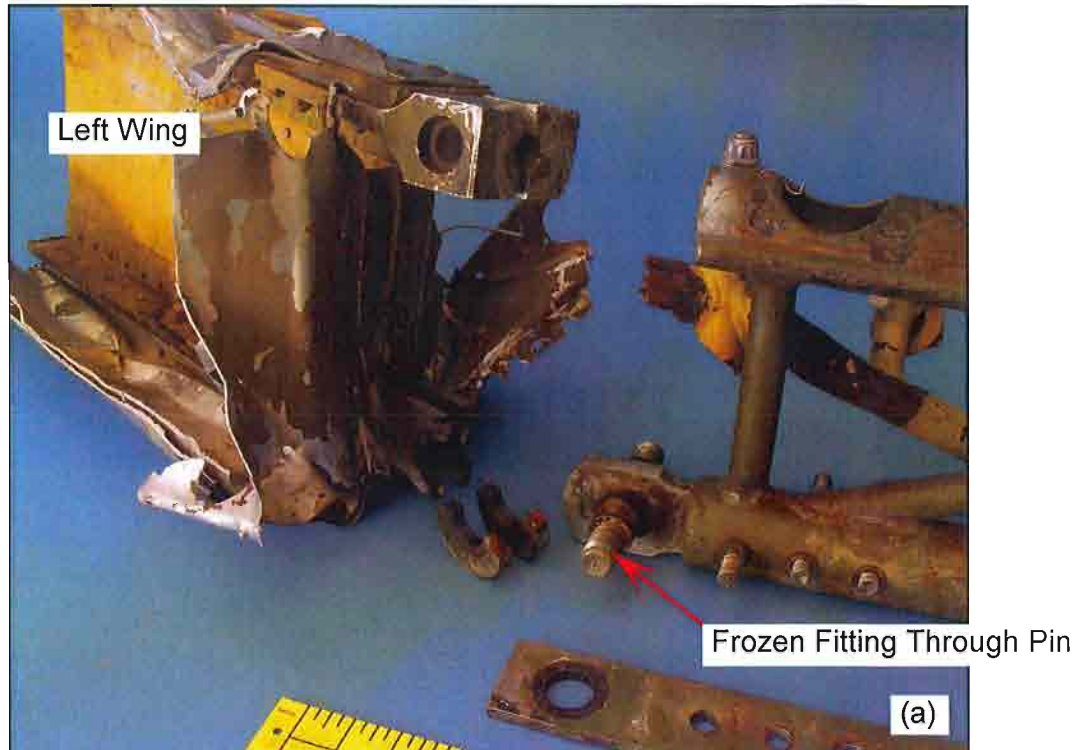
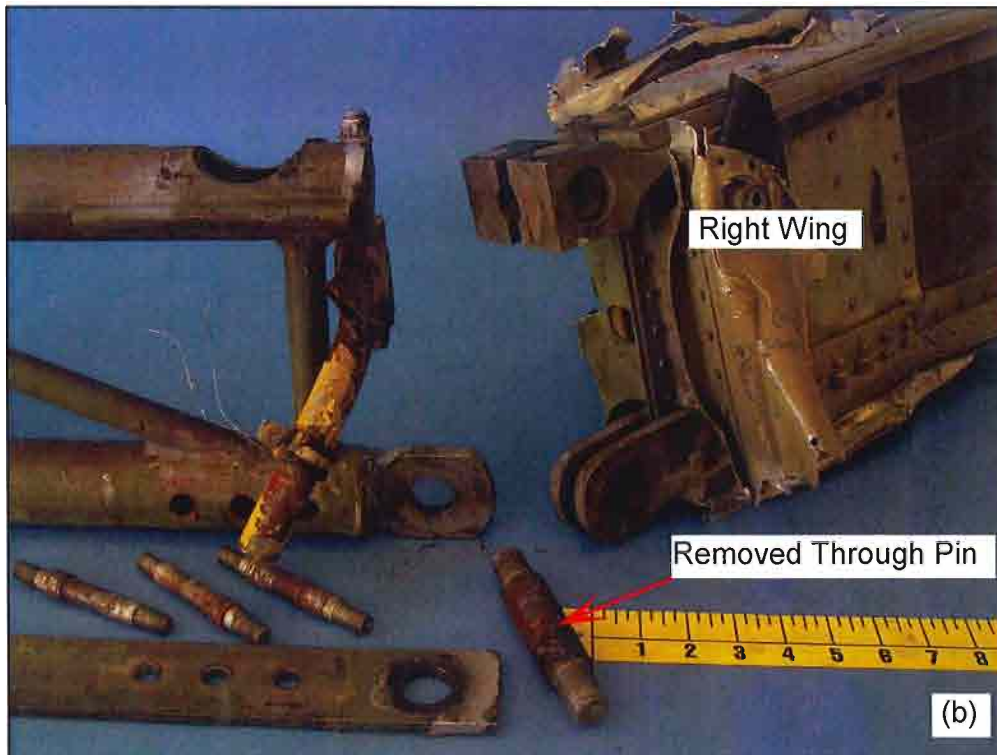
Both wing attachment areas of the carry-through structure were disassembled as displayed in figure 12. On the left side the lower through pin was frozen in the carry-through fitting and would not move even after several heavy hammer blows. Corrosion products were visible in the space between the pin and the fitting. The circumference of the pin was also heavily corroded in two bands corresponding to the locations of the wing fittings, see figure 13 (a). The cadmium plating was nearly intact on the carry through fitting and only light localized corrosion was visible on the faces.

Figure 12--The disassembled left (a) and right (b) wing attachments. Note the frozen through pin lodged in the left wing carry-through fitting.

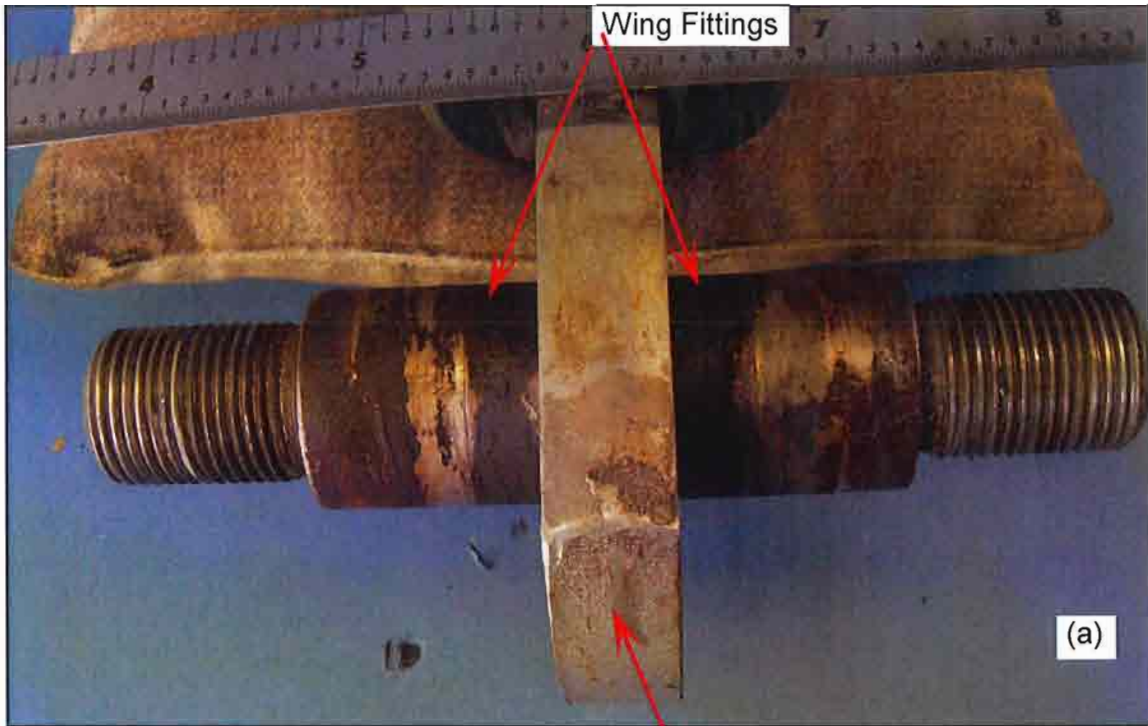
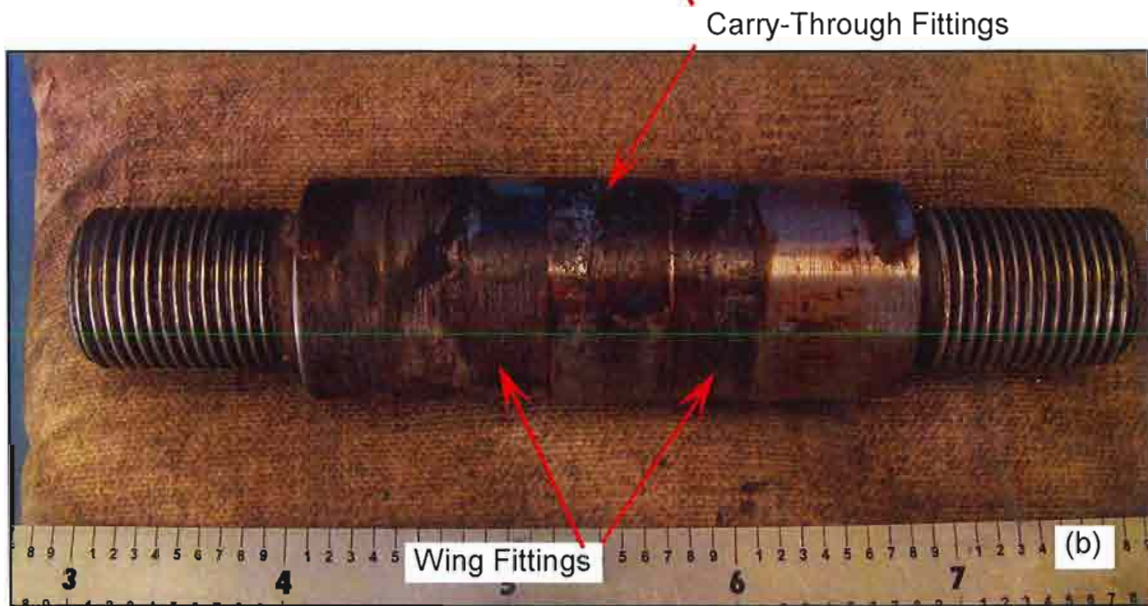
The right wing attachment was also disassembled with the through pin easily extracted from the fittings. The pin had some areas of corrosion corresponding to the locations of the wing fittings and carry-through fitting as shown in figure 13 (b). Most of the cadmium plating was intact on the fittings and only light corrosion was present. The pin bores on the wing fittings showed some corrosion but most of the original surfaces with machining marks were present and undamaged. The lower spar cap fittings from the right wing were visually examined for evidence of cracking in the areas corresponding to the fatigue cracks in the left wing, and no evidence of cracking was noted. The upper spar cap bolt was in place but found to be bent when removed. The bend direction was consistent with the rearward bend of the adjacent spar.

Figure 13--The through pins from the left wing (a) and right wing (b) showing corrosion at the interfaces with the wing and carry-through fittings.
