Those Dang Dinged Oil Filler Caps!

by Jason Edge

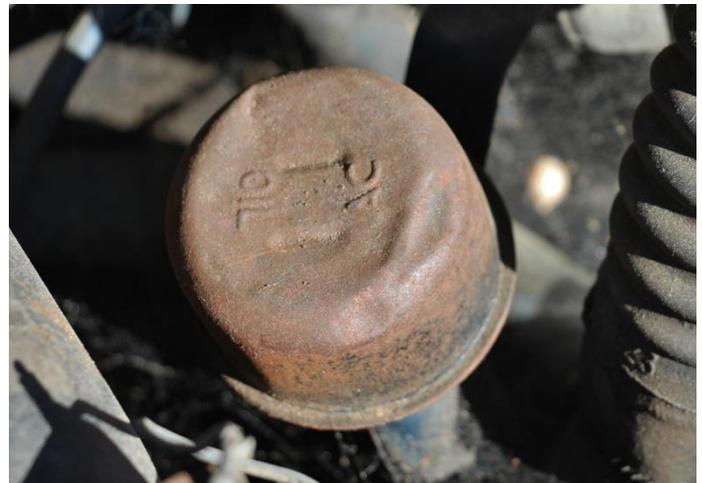
I don't know how many customers I have had to relay the repeated sad story that all I have is a box of dinged up caps! I got into bringing in parts cars way back for the very purpose of finding good parts for my 1964 Coupe DeVille, and at some point I found an oil cap with just one minor ding which you see on the right in picture below along with 3 other less than pristine specimens:

Oil Filler Cap with Typical... but Mysterious... Dings!

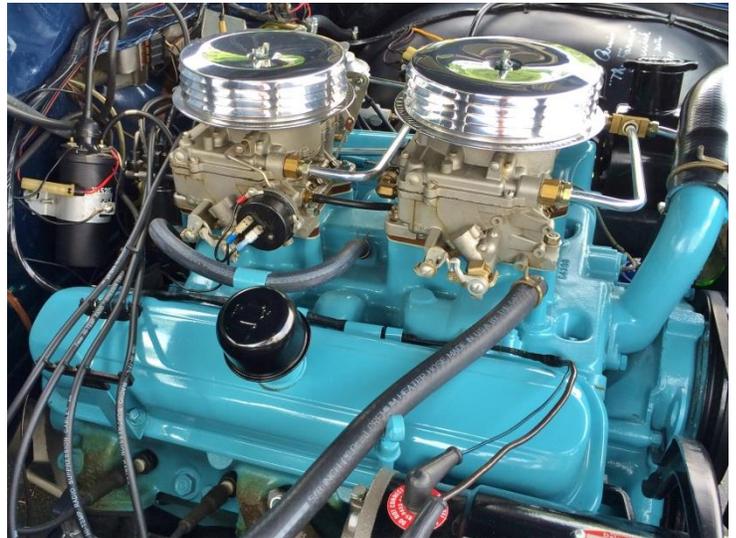
The overall shape of the cap is the same, and the indentions are close, but the AC and Oil lettering, especially the AC, is not as distinct as on the original caps and the text is closer together. With that said it is a close approximation and would not consider it different enough that someone would get "dinged" (no pun intended) for points if judged at a CLC Grand National or similar judged event.

To the right you will see my original oil filler cap on the left, the Corvette Central caps at center and right. These are very similar but you will note a difference in the "AC" lettering.

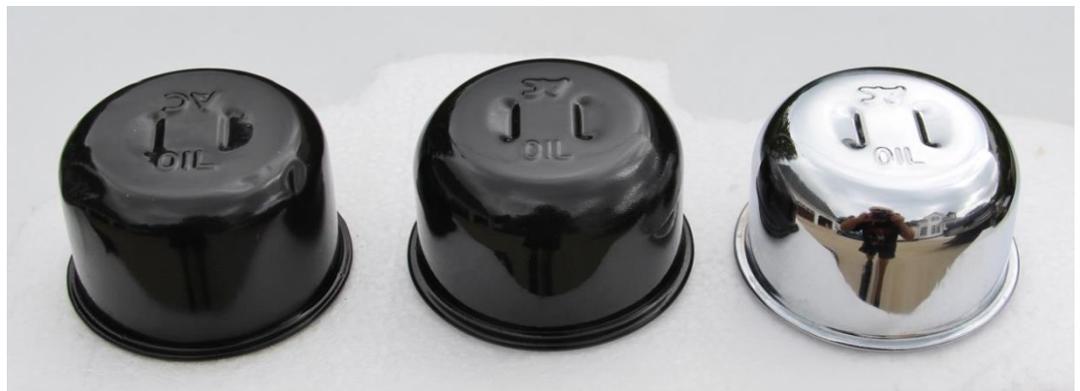
Oil filler cap on 1962 Pontiac Catalina purchased from Corvette Central

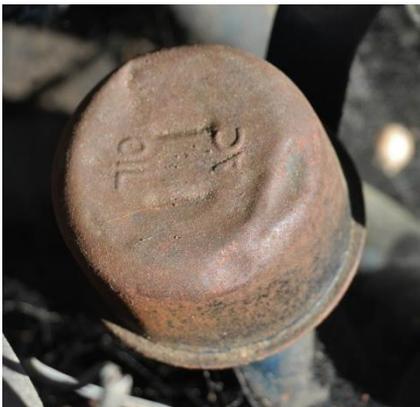
To the left is the oil filler cap as pulled in with parts car.
