# **THE WATER QUALITY PROBLEM STATEMENT FOR THE ROCKY RIVER WATERSHED**

**Rocky River Semi-Annual Report  
Appendix G  
May 2006  
Updated February 2010**

**This publication was prepared by the Northeast Ohio Areawide Coordinating Agency on behalf of the Rocky River Watershed Council. This publication was financed in part through a grant from the Ohio Environmental Protection Agency and the United States Environmental Protection Agency, under the provisions of Section 319(h) of the Clean Water Act.**

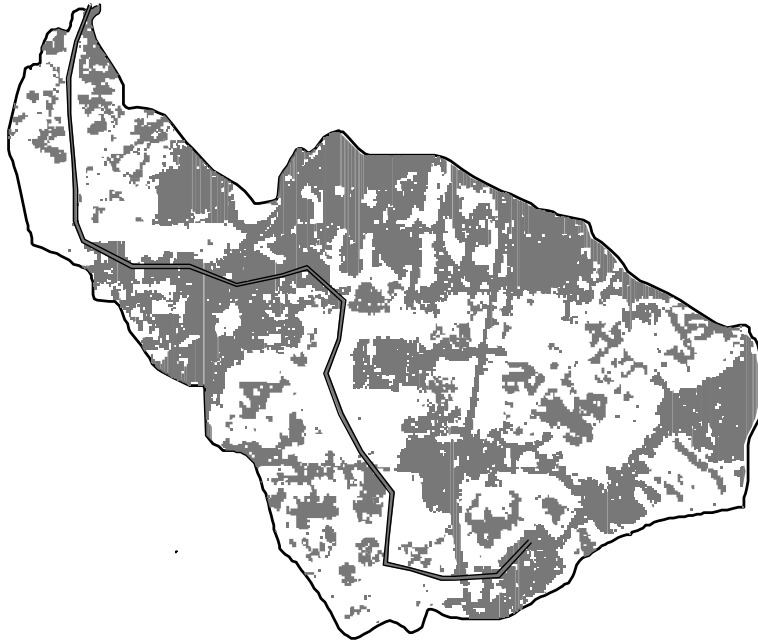
# Urbanized Lands in the Abram Creek Watershed

Use Attainment Status  
Non Attainment

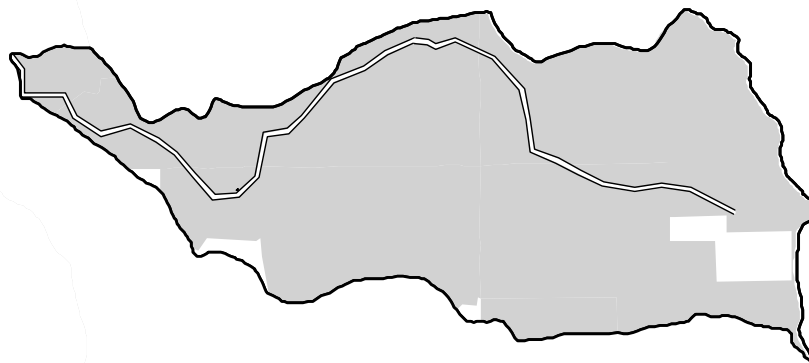
## Status of Sanitary Sewer Service in Balwin Creek

Dark Areas are currently served with sanitary sewer service.

Light areas will continue to utilize HSTs.

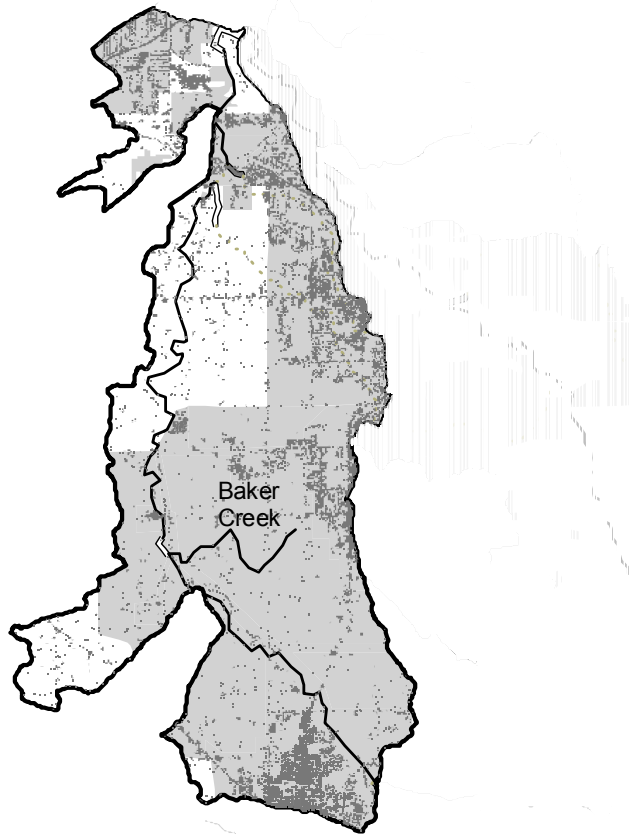
## Urbanized Lands in the West Branch of the Rocky River

Darkened Areas are served with sanitary sewers or are likely to be sewered in the near future.

See preceding West Branch maps for general conditions in Baker Creek. Baker Creek is unlabeled on these maps but is shown. It is the most upstream tributary that enters the West Branch from the East.
